# Manhole Inspection Summary

Manhole # S29E\_\_028MH

Insp Date: **1/28/08 3:27 PM**

**Location** Address: **730 DR BENJAMIN QUARLES PL** Cross Street: **SARATOGA ST**

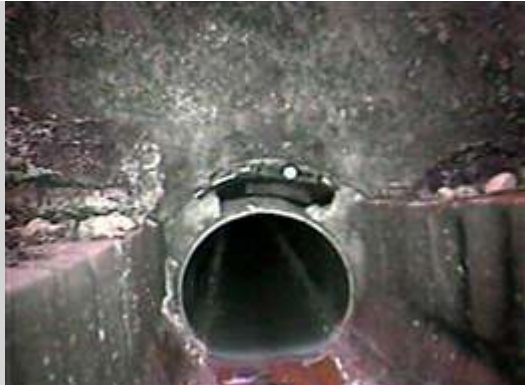
12 O'Clock Outflow

8 in. Circular Gravity Sewer  
Pipe Out @ 12 O'Clock

Pipe Height: (in.) Direct  
Pipe Material: **PVC** ☐ Pipe Lined  
Invert Depth: **10.35** (ft.) Flow Characteristics: **Slow**  
Deposits: ☒ None ☐ Mud ☐ Sludge ☐ Debris ☐ Grease  
Silt Depth: (in.) Deposits Extent:  
Infiltration: **None** Pipe Seal Cond: **Broken**

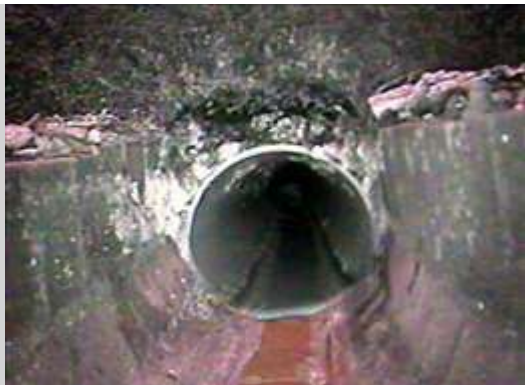
6 O'Clock Inflow

8 in. Circular Gravity Sewer  
Pipe In @ 6 O'Clock

Pipe Height: (in.) Direct  
Pipe Material: **PVC** ☐ Pipe Lined  
Invert Depth: **10.25** (ft.) Flow Characteristics: **Slow**  
Deposits: ☒ None ☐ Mud ☐ Sludge ☐ Debris ☐ Grease  
Silt Depth: (in.) Deposits Extent:  
Infiltration: **None** Pipe Seal Cond: **Sound**
